WESTERNTM
SPECIALTY CONTRACTORS
CONFIDENCE THROUGH PERFORMANCE

Western Education: The Learning Platform

Presentation Overview

Types of Roofing Systems

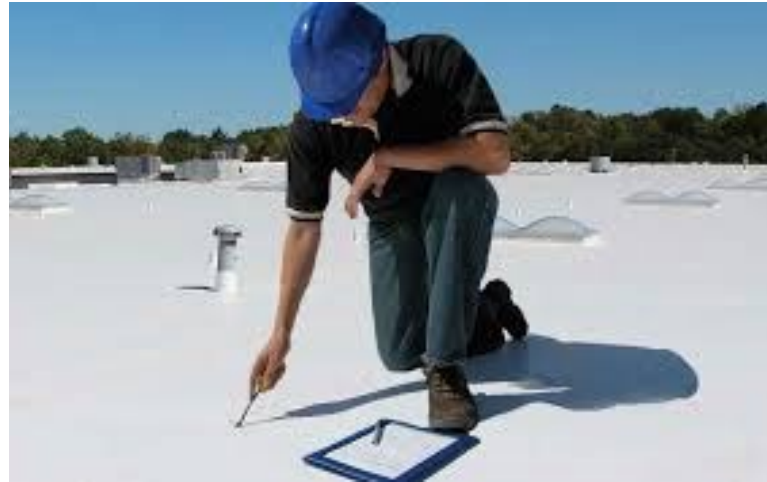
- Tenting
- Holes
- Ponding water
- Alligatoring

- Split seams

- Wrinkling
- Roof flashing
- Failed coatings
- Blistering

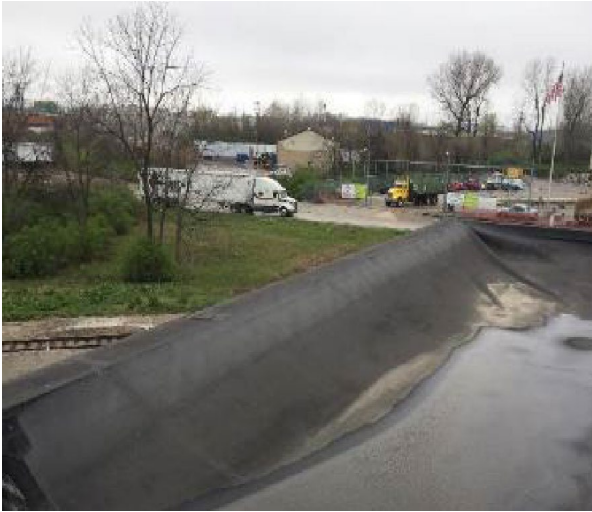
Tenting

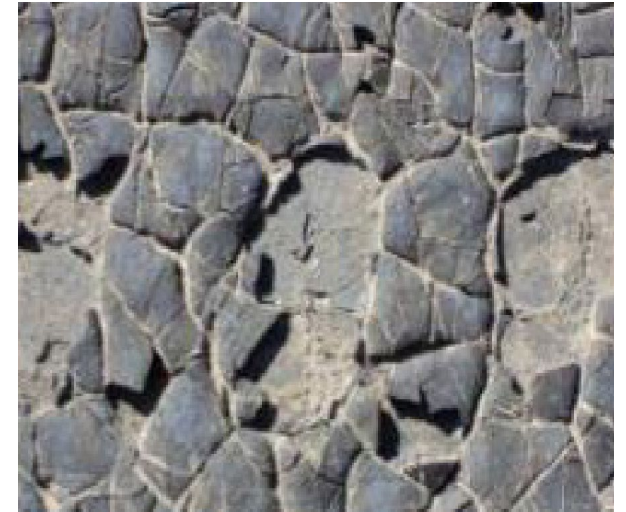
Cracking/
delamination/
rust

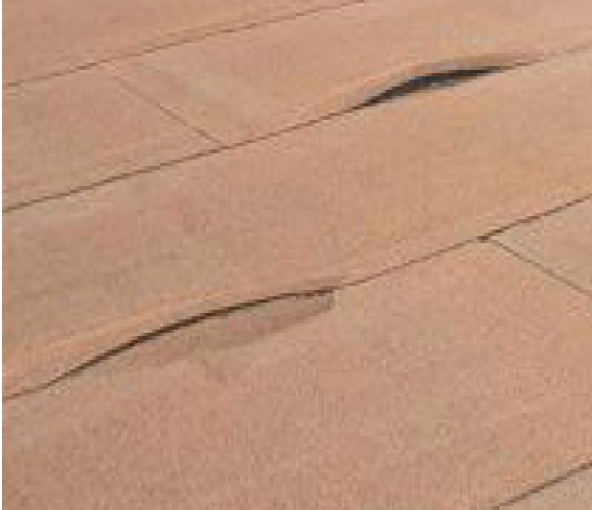
Blistering

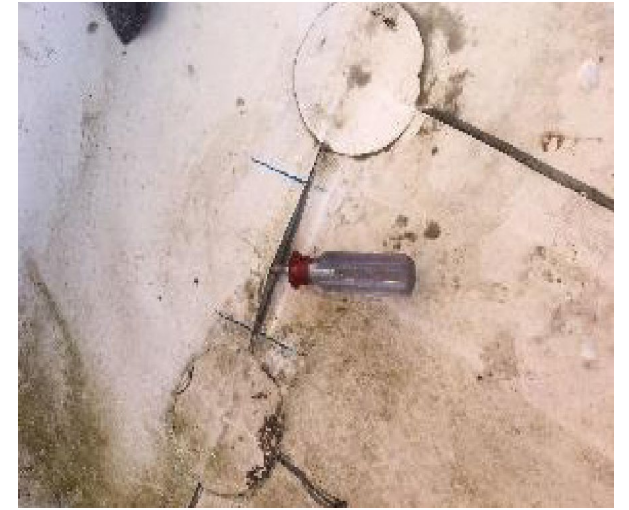
Split Seams

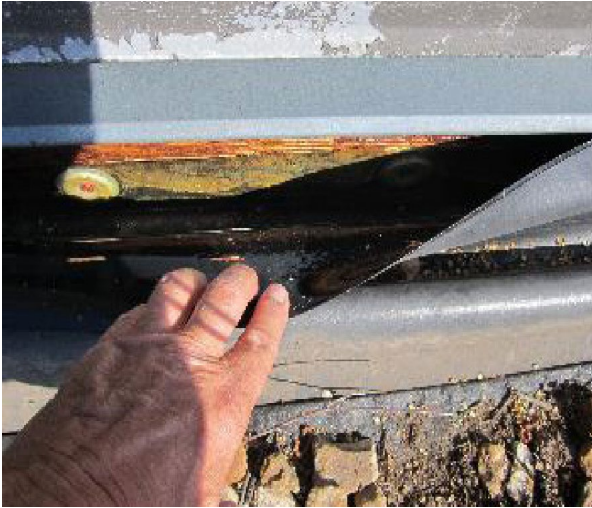
Failed Flashing

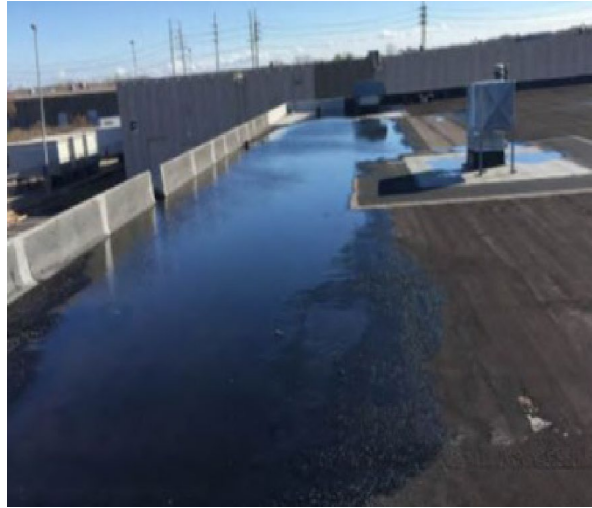
Ponding Water

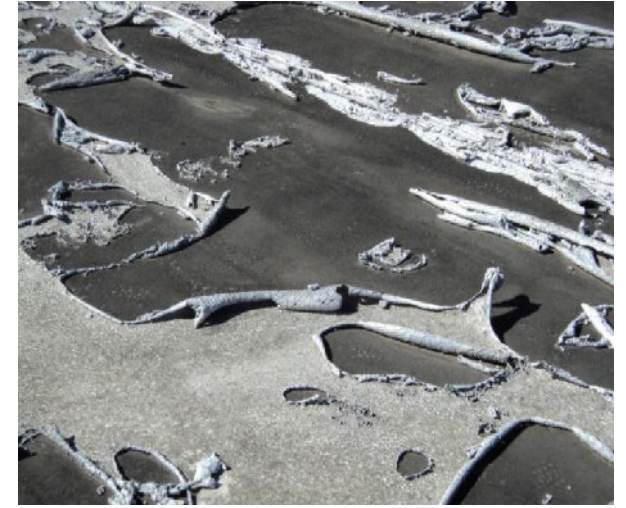
Failed Coatings

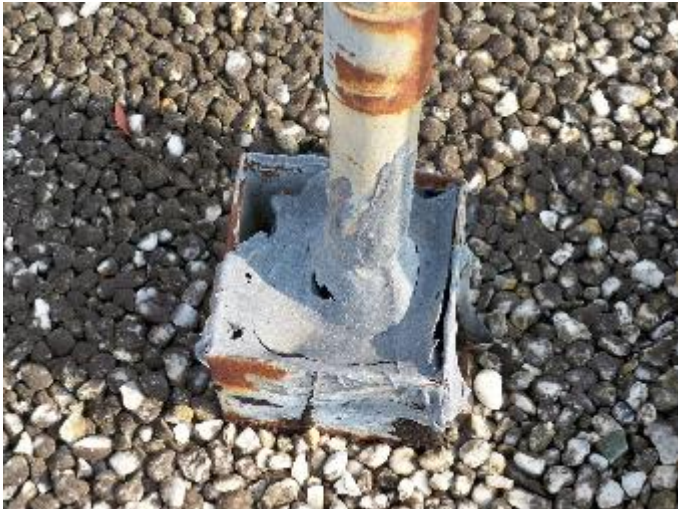
Deteriorated
Pitch Pocket

- Replace sealant at terminations
- Reseal pitch pockets

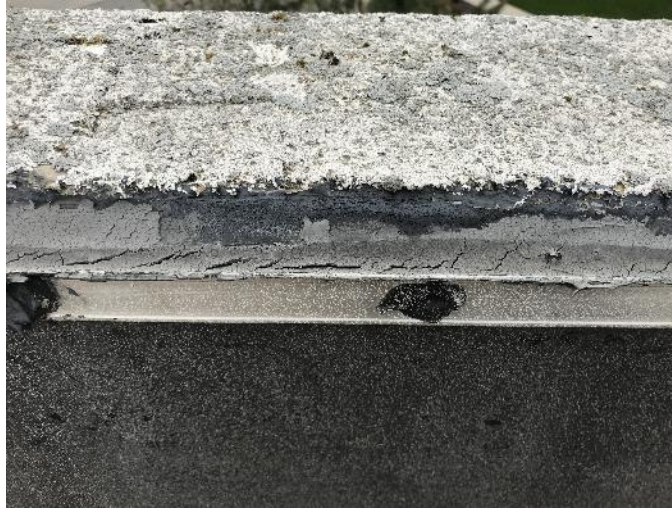
Failed
Termination
Bar Caulk

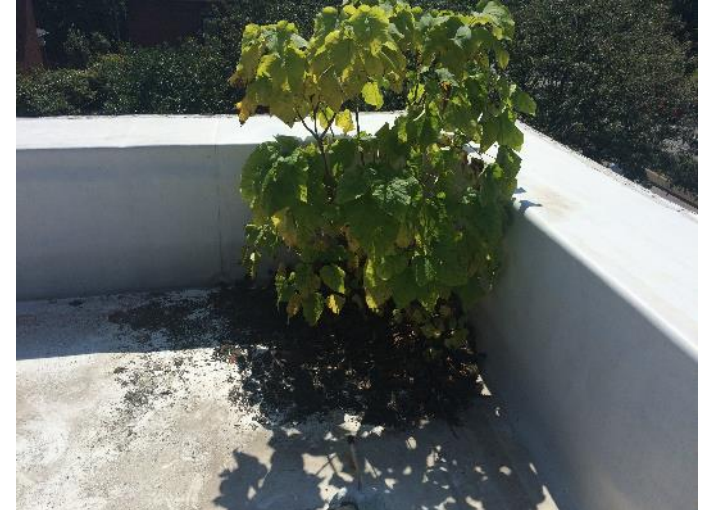
Organic Debris

- Inspection by roofing professional
- Maintenance Items:
 - Remove organic debris
 - Inspect for damage
 - Patch holes

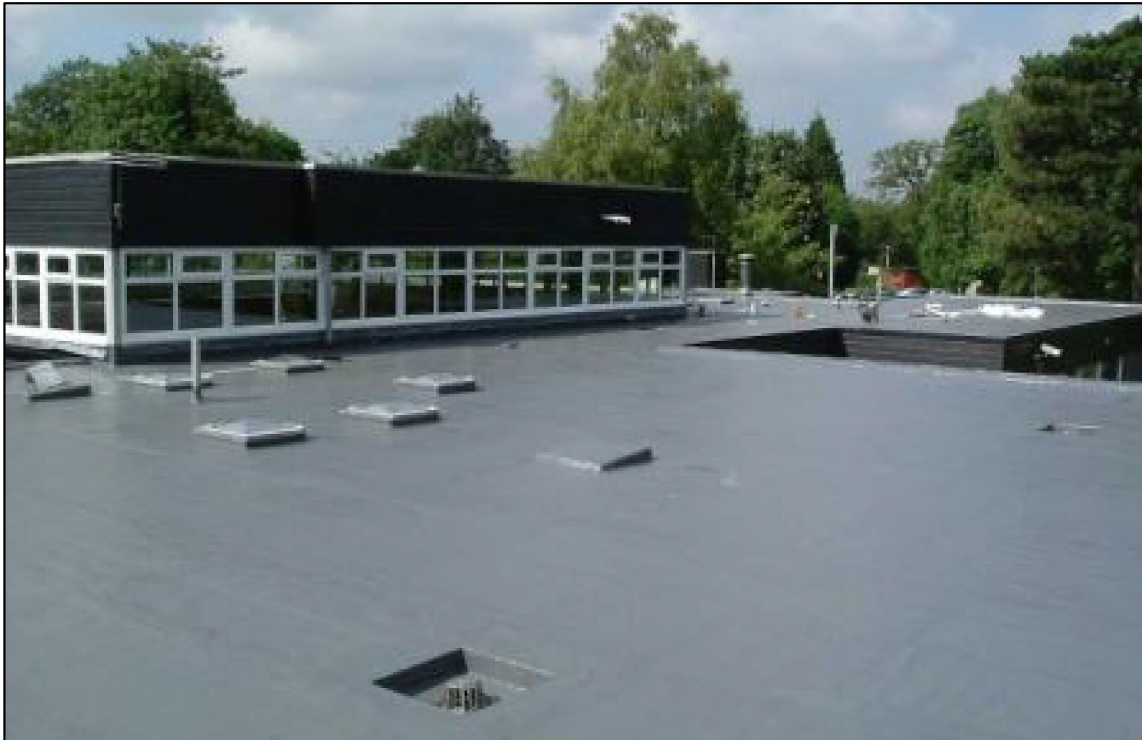
Liquid Applied Membrane (LAM)

- Restoration of existing roof
- Increases useful life
- Eco-Friendly
- Not considered an additional layer of roof
- Considered a repair
- Depreciate in one year

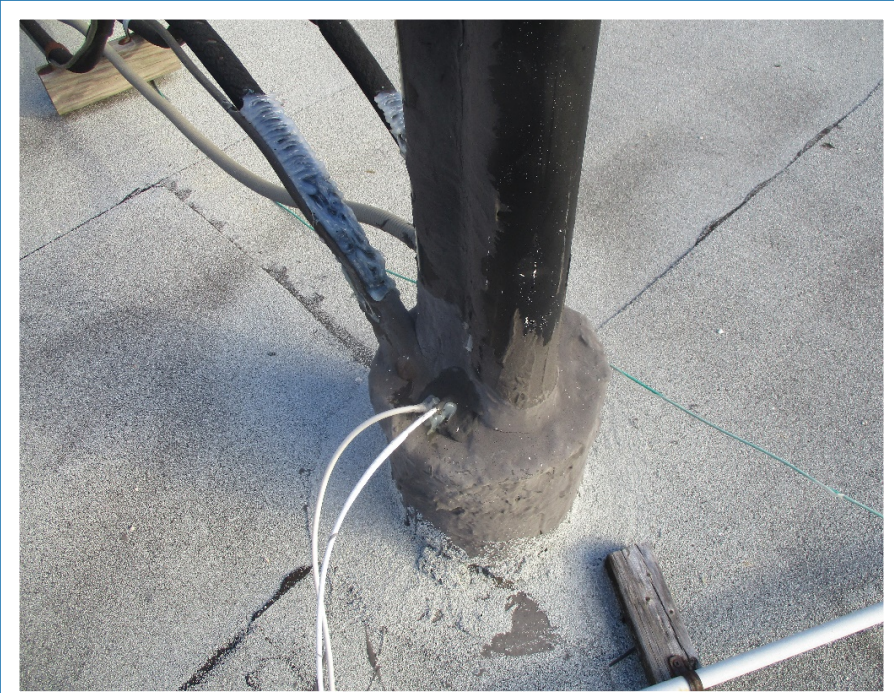
Improper Wire Flashing

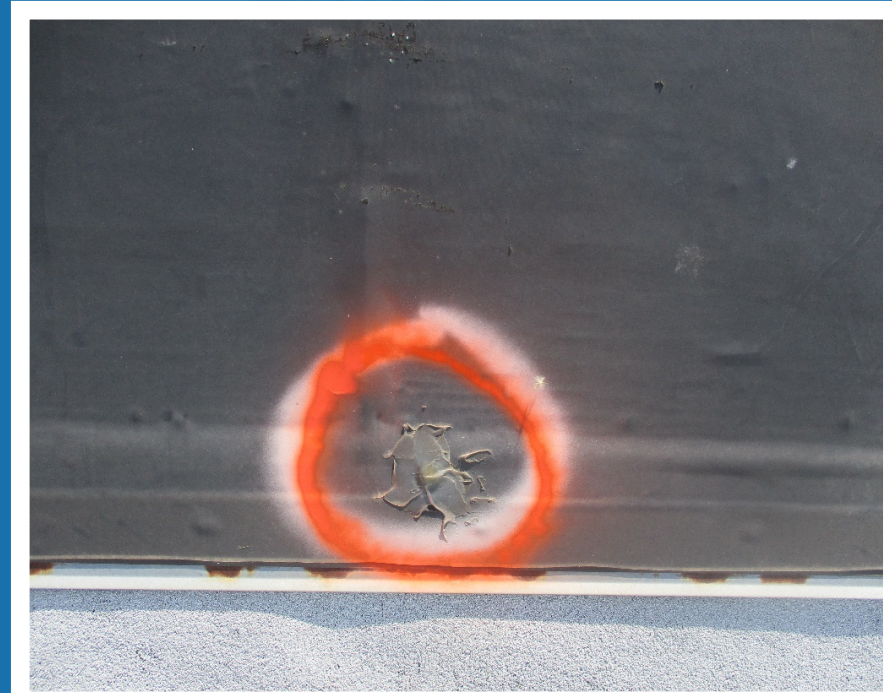
Non-compliant repair attempt

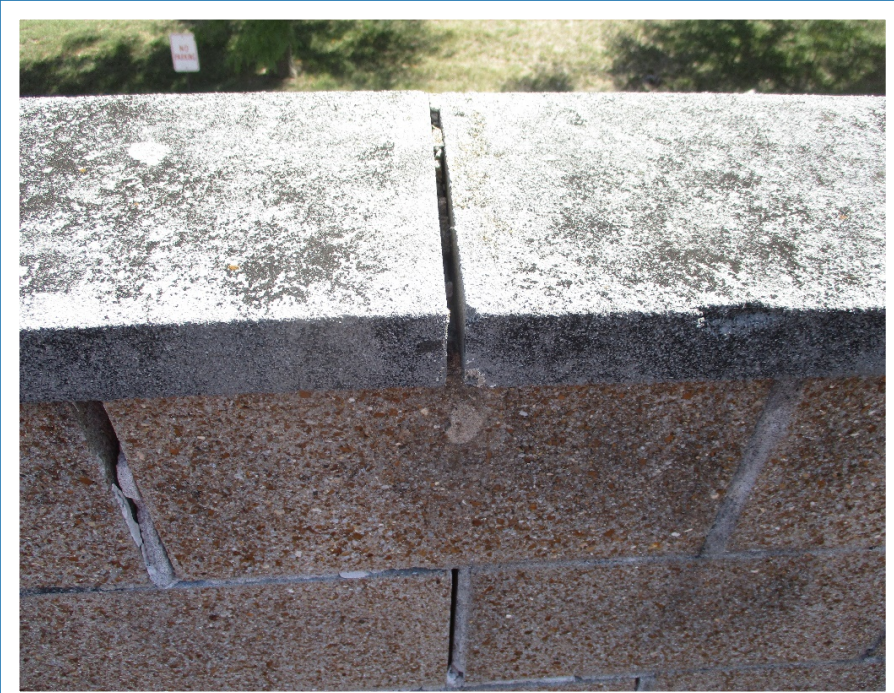
Deteriorated/Missing Mortar

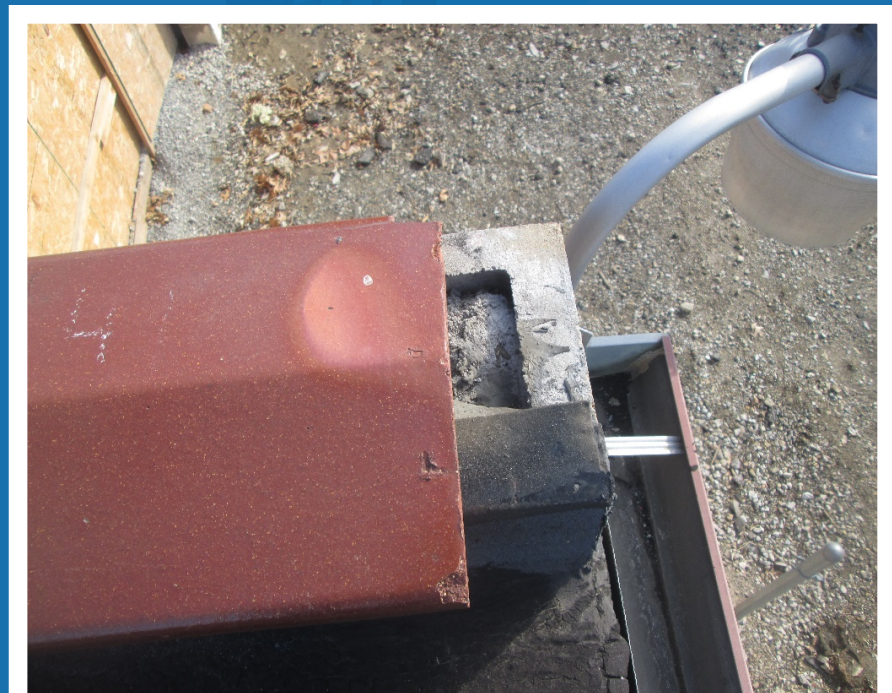
Exposed Inner Wall

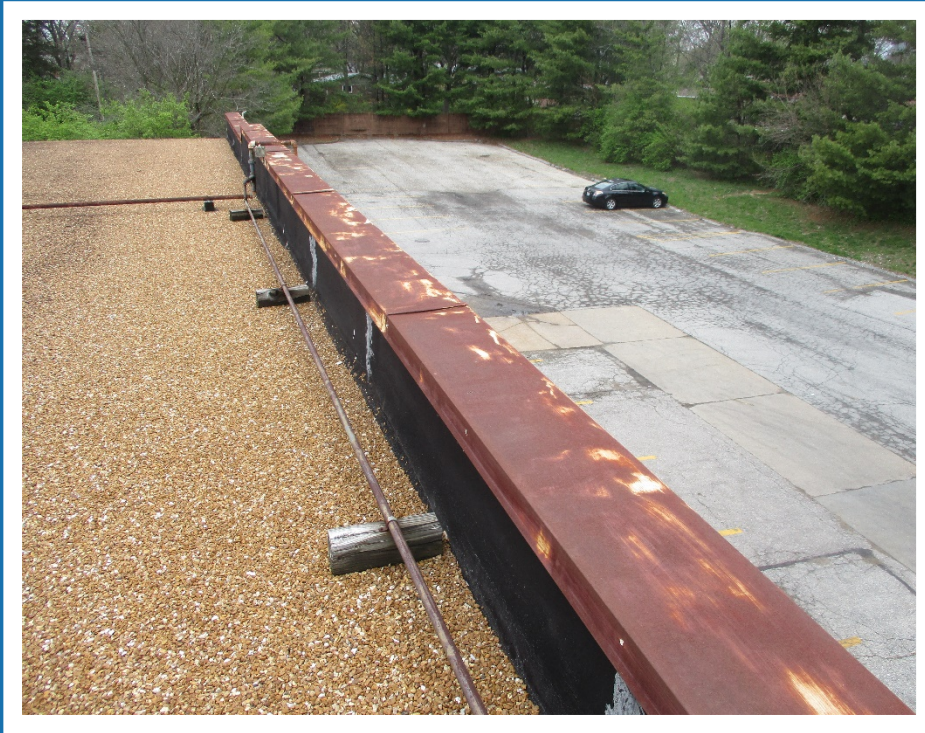
Rusted Metal Coping

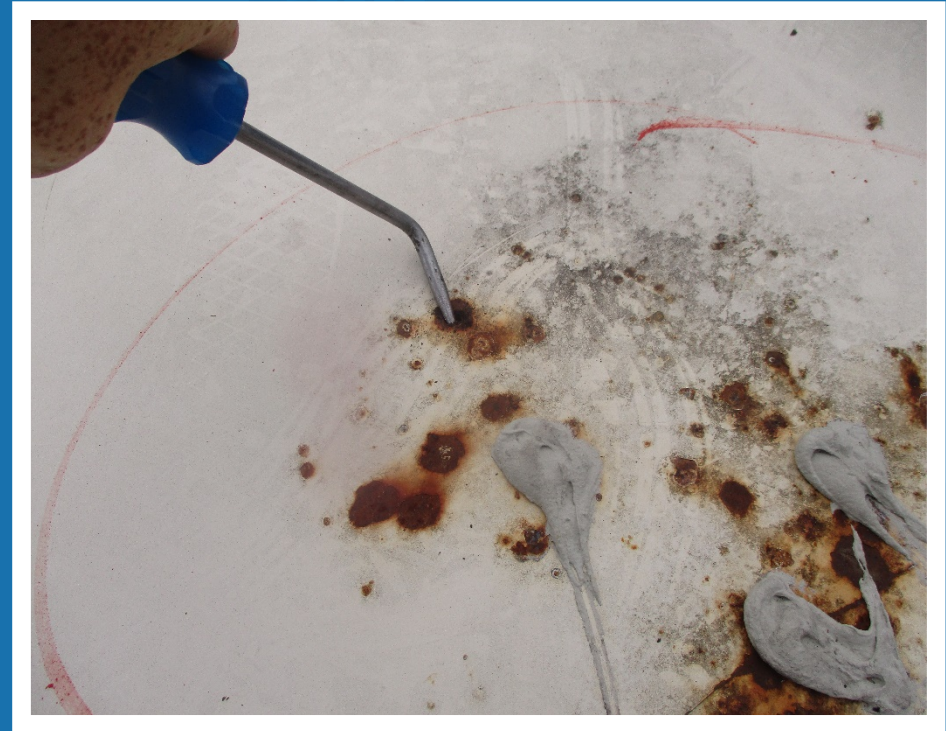
Holes Because of Rusted Coping

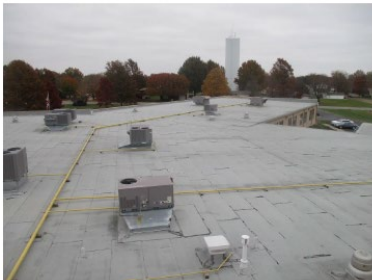
Photo 2: Overview photo showing Roof 1. The roof was observed to be performing properly with minor repairs and maintenance items recommended.

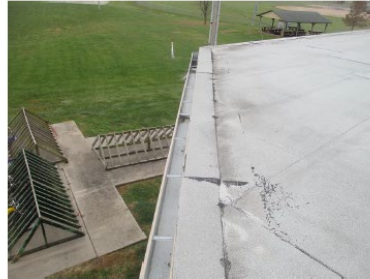
Photo 3: Overview photo showing the perimeter gutter observed to be performing properly.

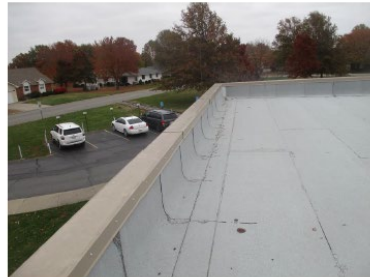
Photo 4: Overview photo showing the perimeter metal coping and flashings observed to be performing properly.

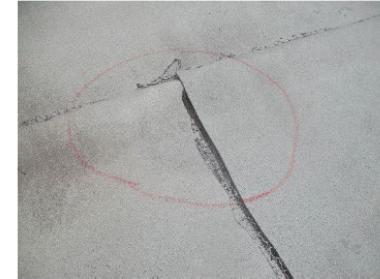
Type/Attachment: The roof membrane consists of a modified bitumen base ply and a granulated modified bitumen cap sheet. Blisters were observed below the modified bitumen membrane in the field of the roof.

Photo 5: Photo showing a blister in the field of Roof 1 that has been marked for repairs.

#	Description of recommended repair/action item. Reference associated satellite image.	Budget
1	A blister was observed below the modified bitumen membrane in the field of the roof. It is recommended to cut out these blisters and install modified bitumen patches installed in cold process adhesive at these locations.	\$1,000.00
2	Drip legs from the gas lines exiting rooftop mechanical equipment were observed to be in contact with the roof. It is recommended to rework the gas lines at these locations to minimize contact with the surface of the roof. This should be performed by your preferred mechanical contractor	\$1,000.00
Repair Estimate Total:		\$2,000.00

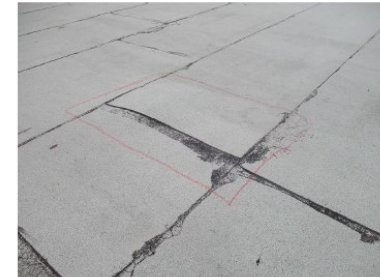
Photo 6: Additional photo showing a blister in the field of Roof 1 that has been marked for repairs.

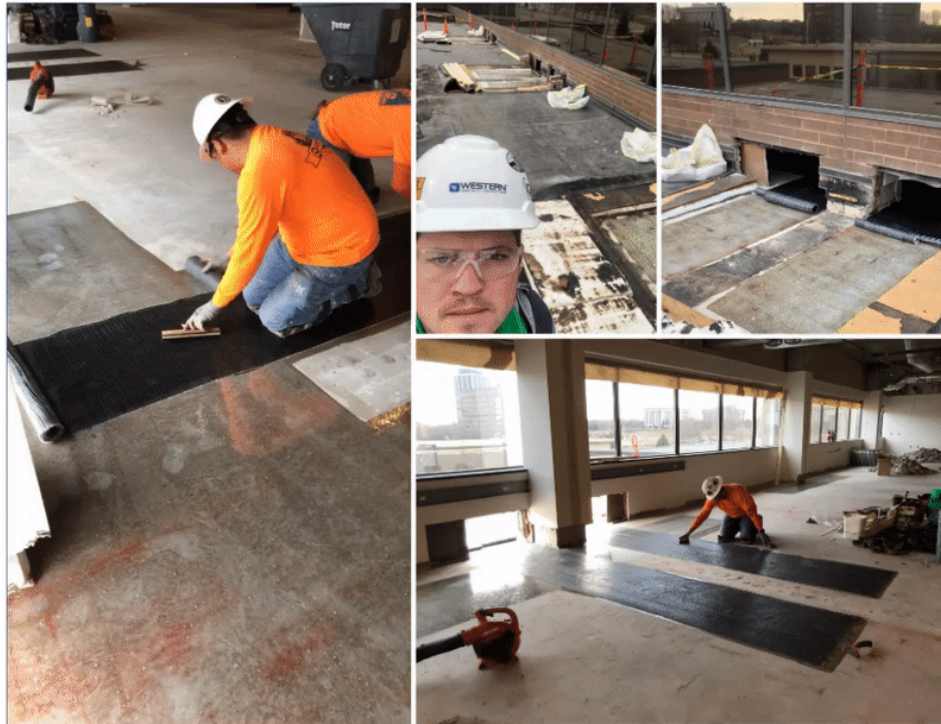
Minneapolis crew installing CFRP on a concrete deck to help support the floor for a new roof top patio for a private client in Edina, MN.

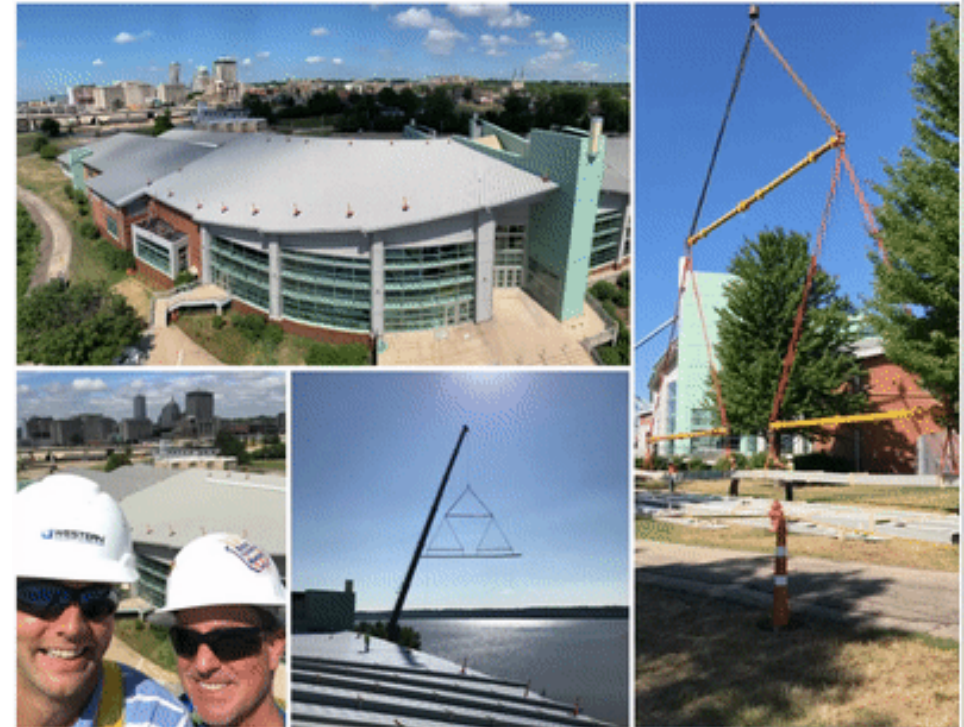
Not an easy project, but a fun one! Some of the fun you see here includes custom 95' field rolled panels being lifted to the roof at the Peoria Riverplex.
